Royal Norwegian Council for Scientific and Industrial Research

TECHNICAL REPORT
Field Maintenance Report
1 January - 30 September 1971

NORSAR Report No 32
Budget Bureau No 22-RO293

Field Maintenance Report

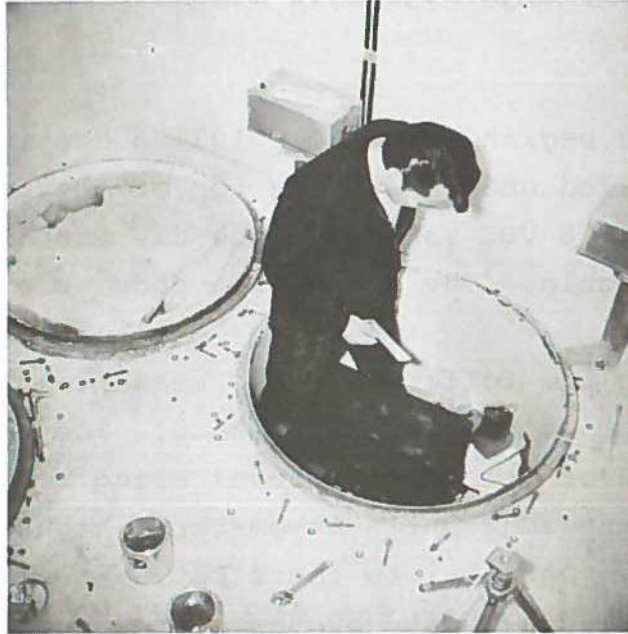
Figure 3.1 The NS and the EW tanks opened,
the NS tank with insulating pads in.

Figure 3.1 shows the NS and the EW tanks opened, the NS tank filled up with insulating pads around and on top of the seismometer, while the pads are removed from the EW tank. A bag of dehydrating substance can be seen beside the seismometer. The technician is returning the thermometer before the lids are put back on.

Based on information from the previous seismic station at Ringsaker, which utilized installations of somewhat the same kind as at NORSEAR, we proposed to introduce an electric heating element in the LP tanks to increase the air temperature somewhat, in an effort to reduce the moisture in the tanks.

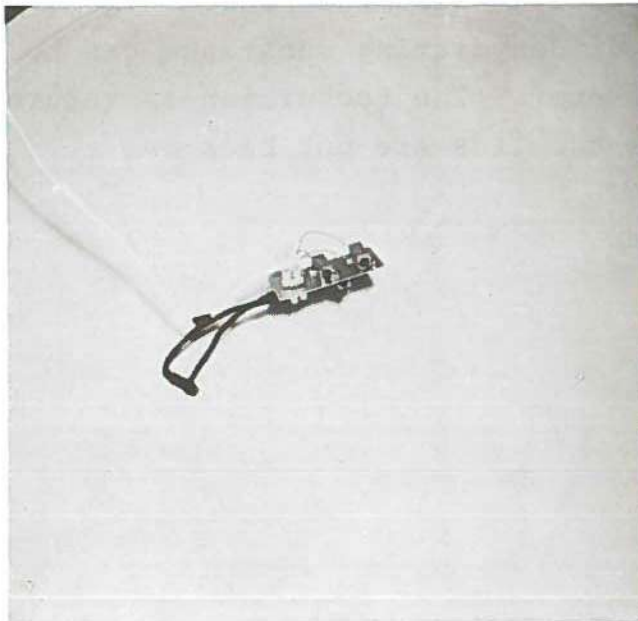
Figure 3.2 The heating element as it was installed
underneath the tank lid.

Figure 3.2 shows the heating element as it was placed underneath the lid.

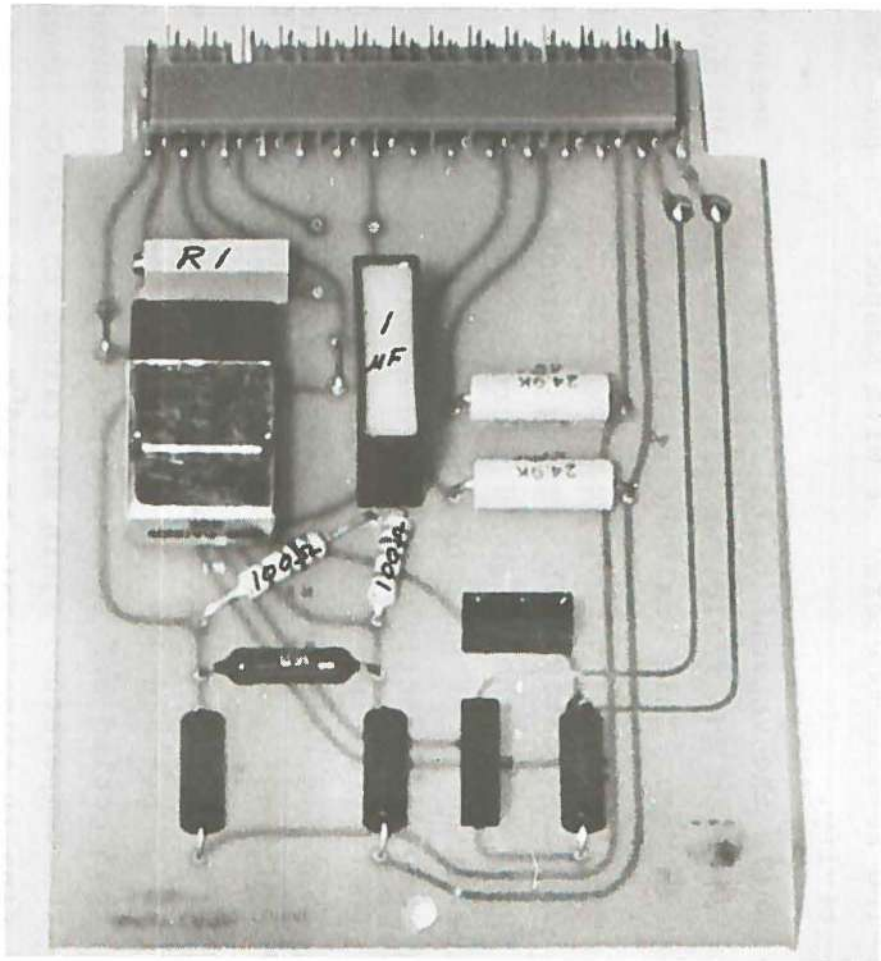
Figure 4.1 Modified RA5 Input Card
Type used at 01C.

Figures 4.1 and 4.2 show modified RA5 Input Cards of respectively "Type used at 01C" and "Type used throughout the array except at 01C". Apart from the damping resistor R1 modification, the cards are also modified as earlier mentioned for suppression of 50 Hz noise in Cal.Amp. mode. The resistor R6 of 200 ohm is replaced by two resistors of 100 ohm in series and grounded over a 1 uF capacitor. Figure 4.3 shows a technician adjusting damping resistor at the WHV, while figure 4.4 shows the test setup in the CTV. By cooperation between WHV and CTV two technicians can now easily adjust the D to proper value.

The damping resistors on the RA5 Input Cards were exchanged with potentiometers which were adjusted in the field to get a D on or near enough 70%. The test was a complete success, and the decision was taken to modify the whole array. The detailed results of this test will be found in Appendix 4, while Appendix 5 holds the final report on "FIELD ADJUSTMENT OF THE SP SEISMOMETER'S DAMPING RATIO" submitted 8 August 1971.

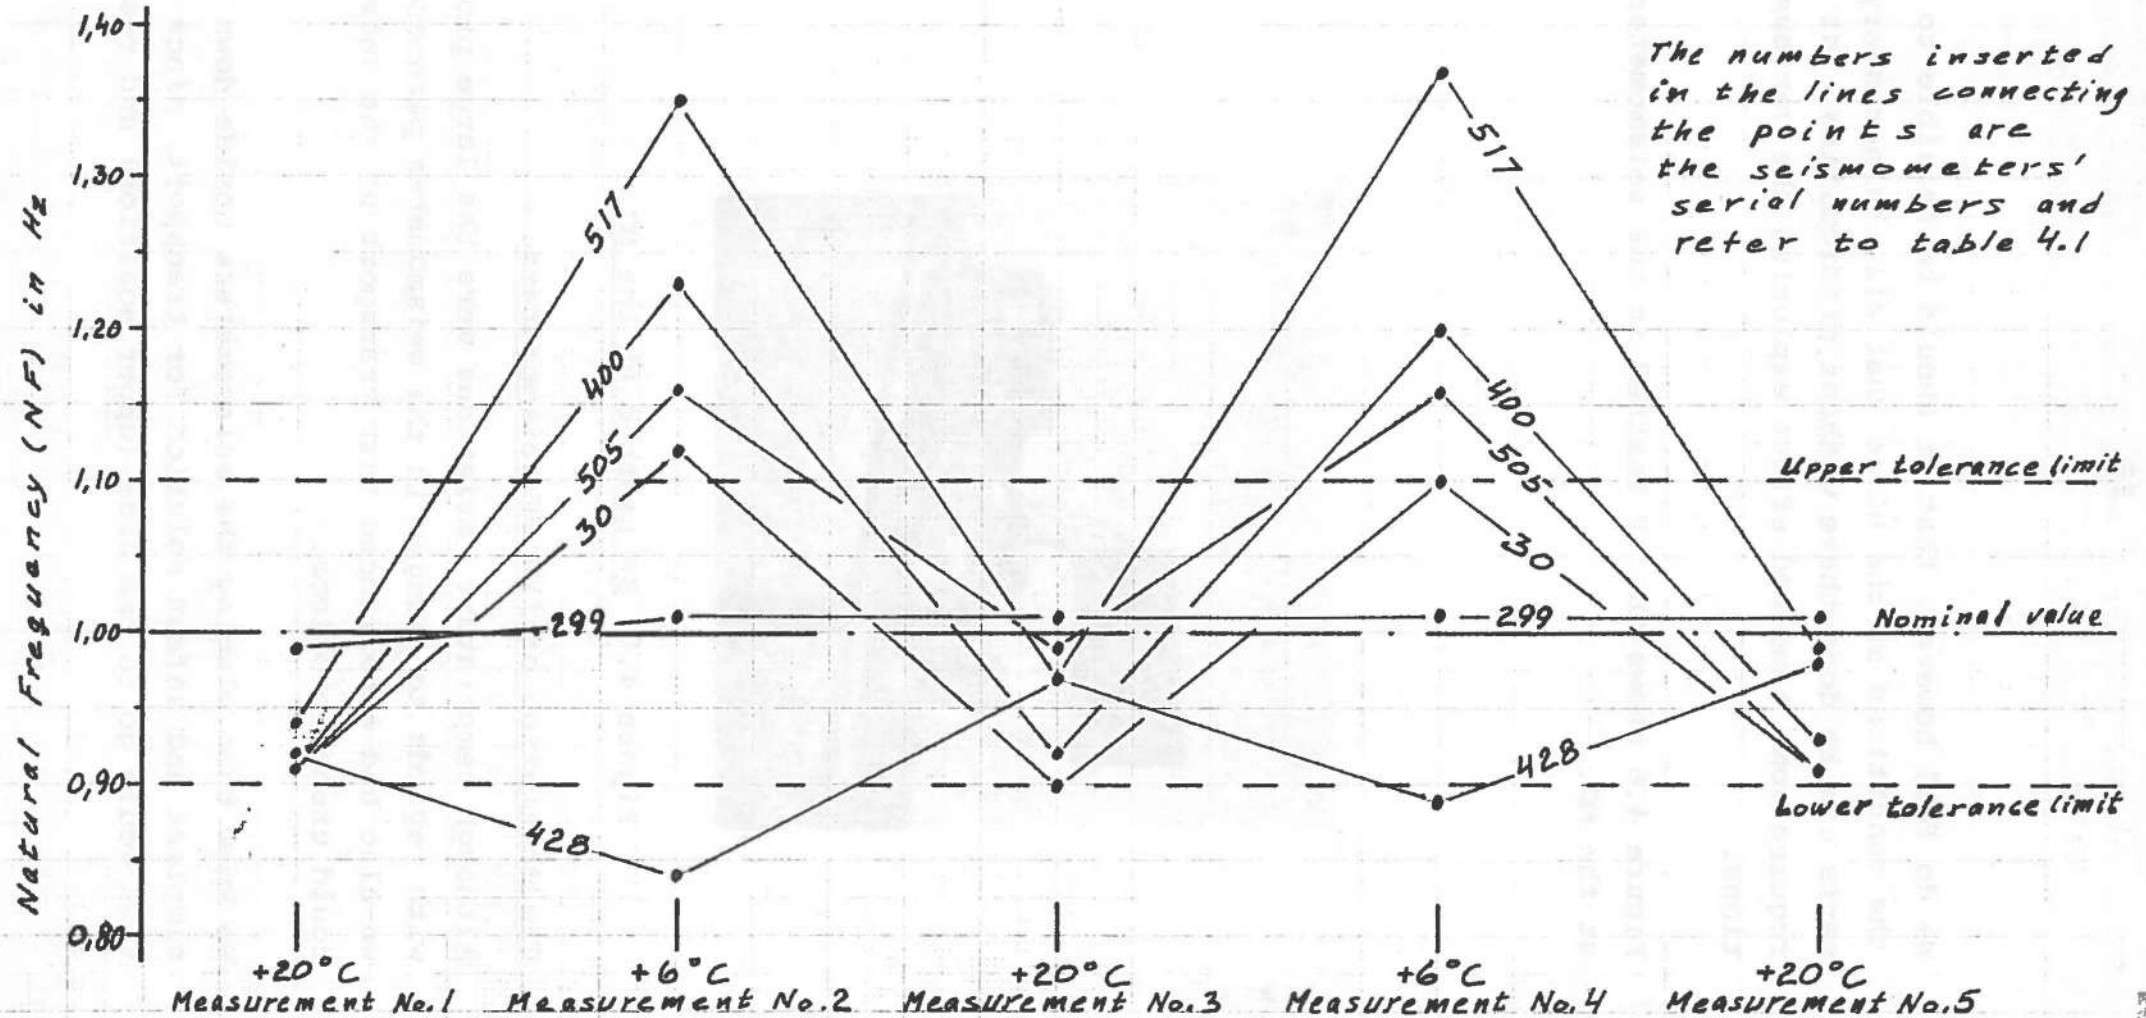
Figure 4.5 Natural Frequency of SP-seismometers in relation to environmental temperature.

A test was conducted with 6 seismometers which were adjusted to NF between 0.9 and 1.0 Hz at +20°C. The seismometers were then cooled off to +6°C and the NF was measured, whereupon the temperature again was raised to +20°C, lowered to +6°C and finally raised again to +20°C, and each time the NF was measured. The results are shown in table 4.1 and in the graph figure 4.5.

The variations in NF with changing temperature and the spread between the various seismometers were about as we had experienced before. But in addition this test showed us, with the uncertainties around the test taken into account, that the NF seems to follow the temperature fairly steadily through the cycles. In other words each individual seismometer seems to end up with about the same NF at the same temperature after a temperature cycling of this nature which should be fairly realistic.

The normal working temperature at the MC would be +20°C and + 6°C would be near the operating temperature for the seismometers in the bore holes. Because of the great variation in NF between these two temperature levels we felt that it would be most correct to adjust the seismometers at a temperature as near as possible to the operating temperature. This would be inconvenient and time consuming at the MC, since the seismometers would have to be brought back and forth between the temperature chamber and the testbed. The conditions at the temperature chamber are not stable enough for adjustment of the seismometers. So, for the time being, with great demand for seismometers in the field, we decided to do the adjustments in the O1A LPV, whereafter the seismometers could be brought (carefully) to the Brumunddal Field Base for cablefitting and potting.

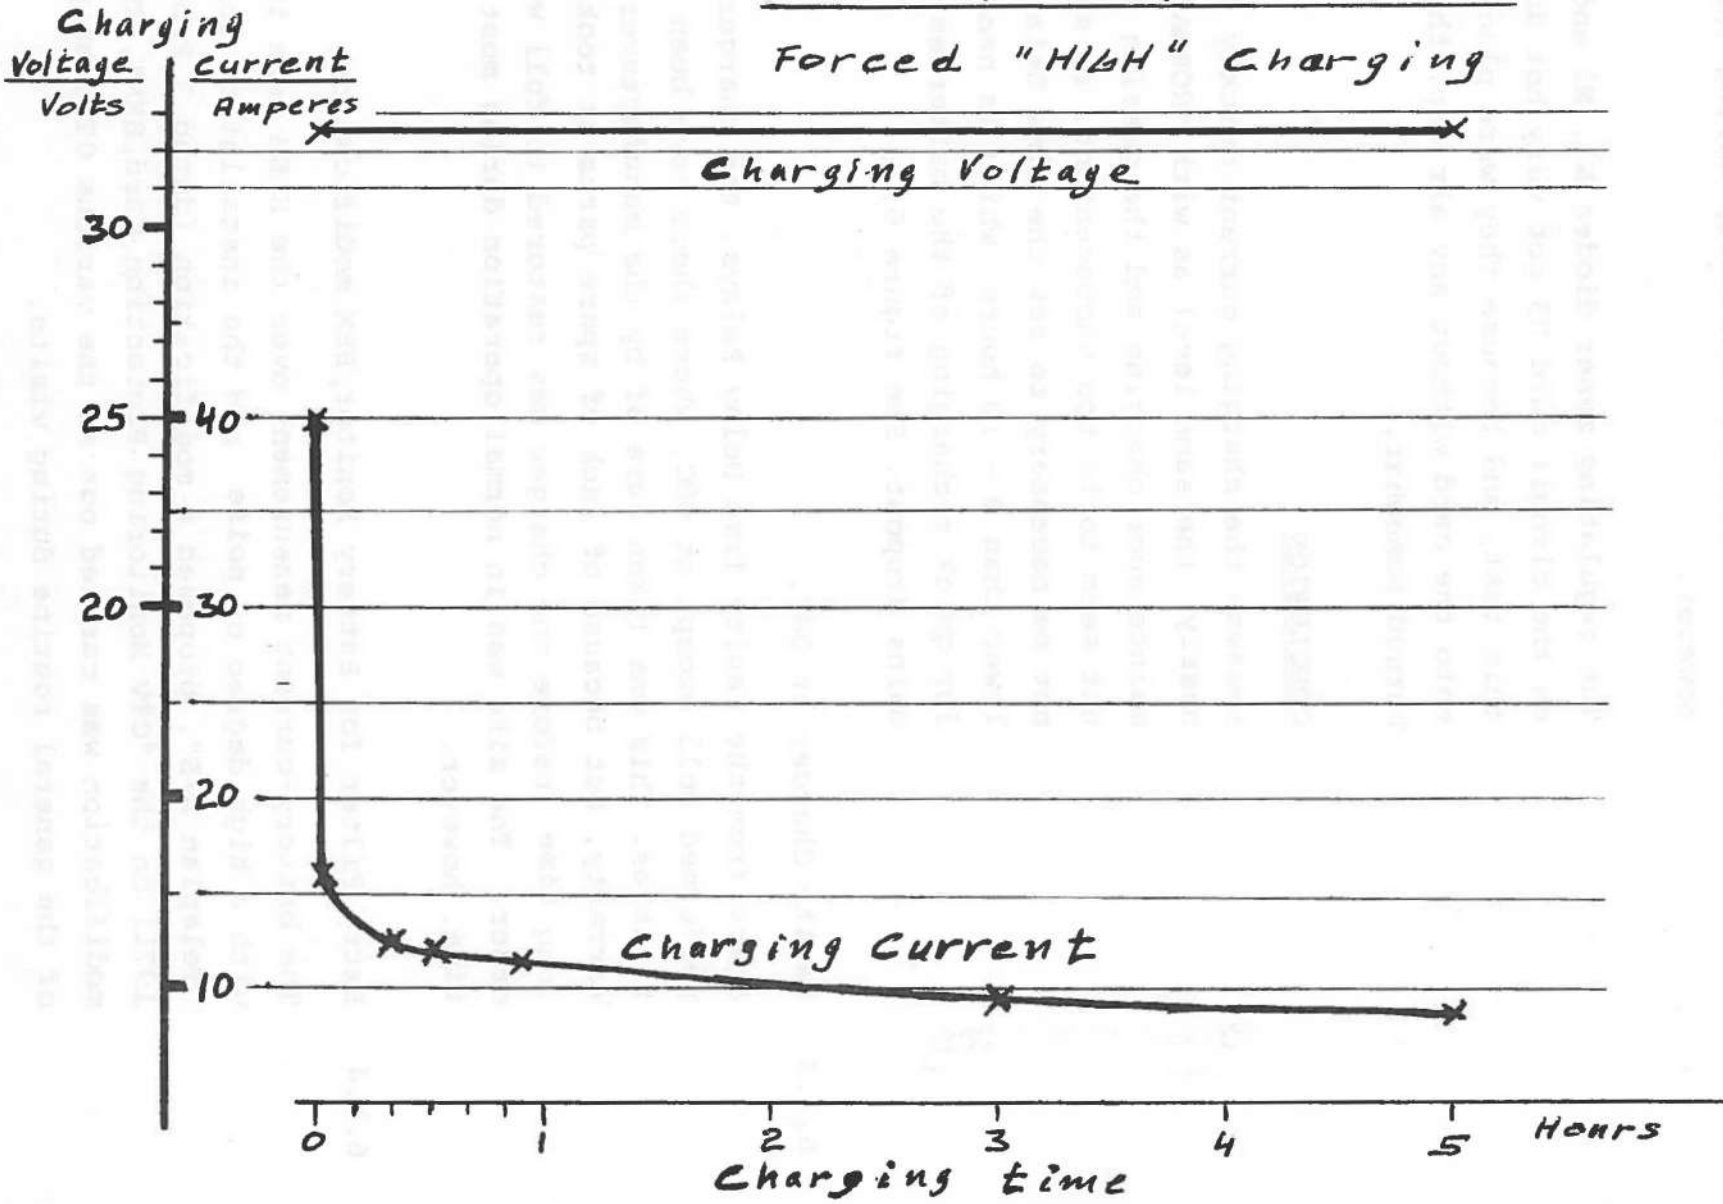
Figure 6.3 Forced "HIGH" Charging.

Gassing started 3 - 4 minutes after start of the test and was increasing towards the end of the period. The electrolyte level did not decrease noticeably during the test, however.

The regulating zener diodes N1, N2 and N3 on the circuit card U3 got very hot during this test, and because they were placed onto the card without any air gap, the card burned somewhat.
