NORSAR

Scientific Report No. 6-73/74

SEMIANNUAL TECHNICAL REPORT NORSAR PHASE 3

1 January – 30 June 1974

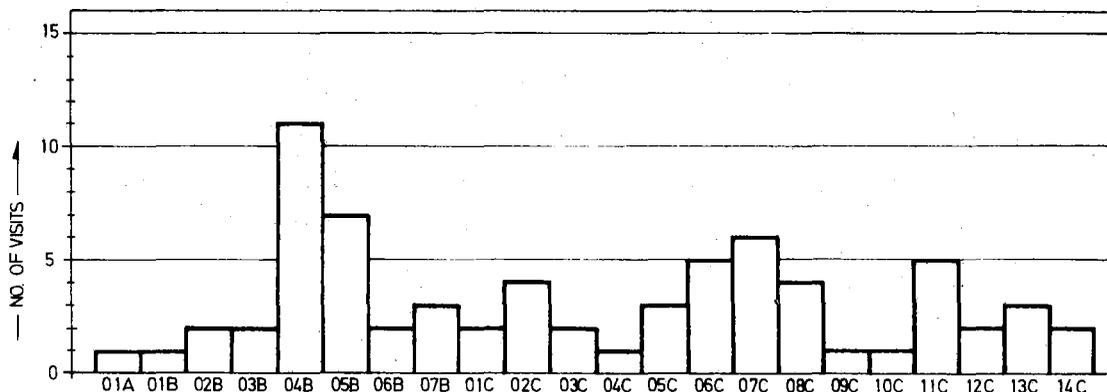
Figure U.1 shows the number of visits to the different subarrays in the period. Excluding visits caused by troubles in the communications system, the subarrays have in average been visited 3.2 times. The large difference from average for subarray 04B is explained by troubles in mass position (MP) bridge and appurtenant power supply (7 visits). At 05B cable breakage repair counts for four visits.

Figure U.1 Number of maintenance visits to the NORSAR subarrays, 1 January-30 June 1974.

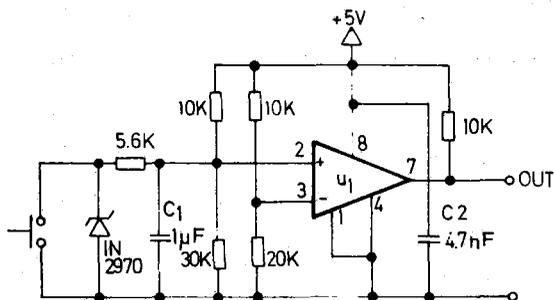
Subject	Action
Depression of noise in SLEM discrete inputs (DI)	Modification is under testing at 05C (modification 3b in Larsen 1973) and at 06C (see Figure U.2).
Too low surge rating of BE protection card	Modified BE cards with 5 W wire-wound resistors are under testing at 11C on all SP channels.
False triggering of CTV water monitor	Modified prototype has been tested at 04B. A report is in print.
Trends towards negative DC offset in the SP/LTA.	Original offset trim potentiometers is replaced by 360 K Ω potentiometer, which gives adjusting range of ± 135 mV (previously ± 30 mV). Modification has been tested at 03B and 05C. Results are presented in Larsen and Nilsen 1974.

Figure U.2 Input comparator with noise filter.
