NORSAR

Scientific Report No. 4-73/74

SEMIANNUAL TECHNICAL REPORT

NORSAR PHASE 3

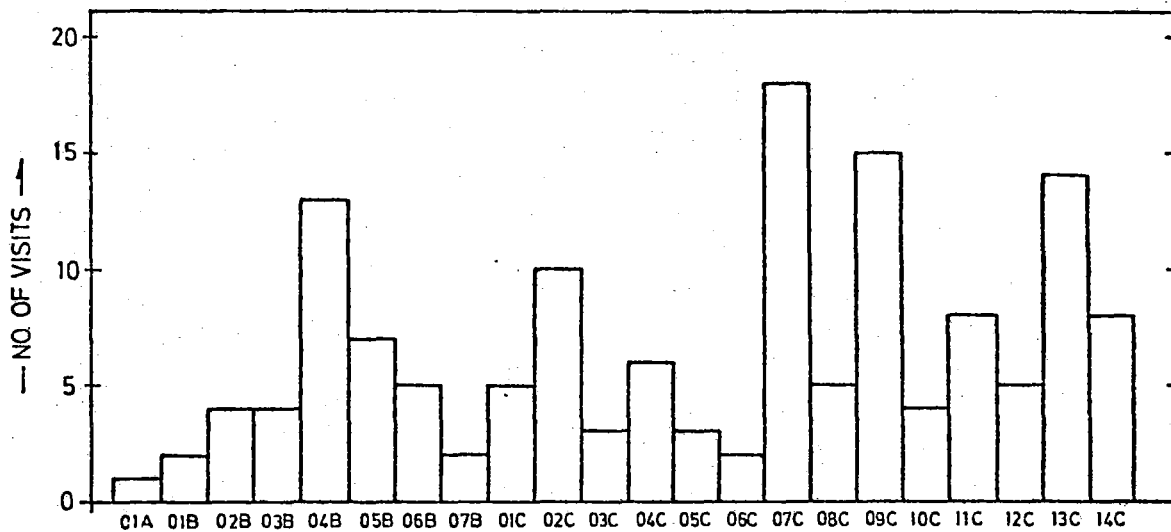
Figure Q1 shows the number of visits to the different subarrays in the period. Excluding visits caused by troubles in the communications system, the subarrays have in average been visited 6.5 times. The large differences

from average for some of the subarrays are explained mainly by power faults and cable breakages.

Fig. Q1 Number of maintenance visits to the NORSAR subarrays, 1 July-31 December 1973.
