NORSAR

Scientific Report No. 5-74/75

FINAL TECHNICAL REPORT NORSAR PHASE 3

1 July 1974 – 30 June 1975

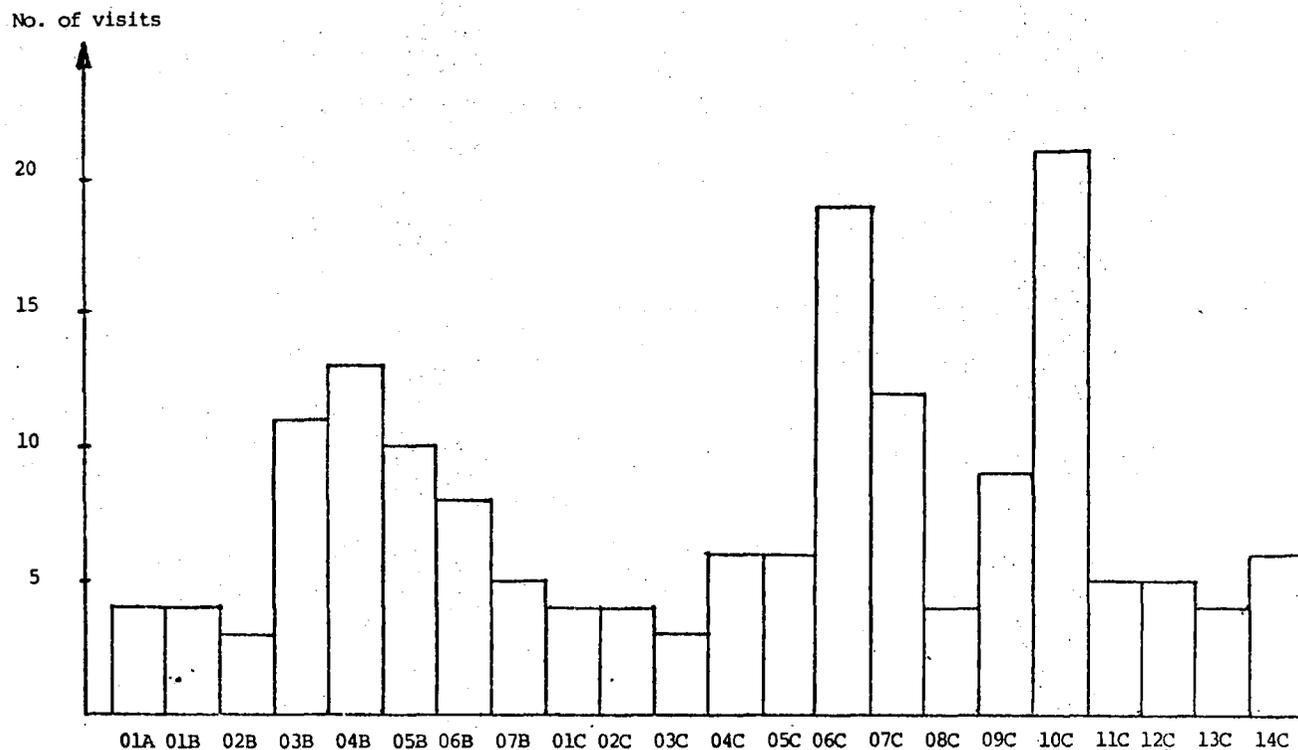
Fig. Y.1 Number of maintenance visits to the NORRAR subarrays
1 July 1974 - 30 June 1975.

Fig. Y.1 shows the number of visits to the different subarrays in the period. Excluding visits caused by troubles in the communications system, the subarrays have on the average been visited 7.5 times. The large difference from average for subarrays 03B, 04B, 06C, 07C and 10C is explained in Table Y.2.
