# World Housing Encyclopedia

*an Encyclopedia of Housing Construction in  
Seismically Active Areas of the World*

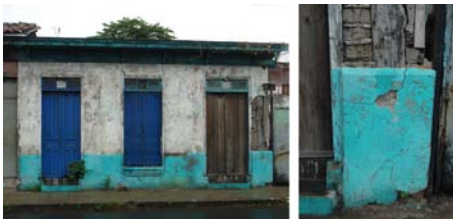
Figure 14. Bahareque building in an urban area with a pedestal made of clay bricks.

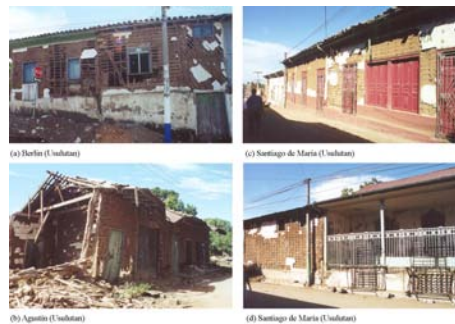
Figure 18. Structural damage to bahareque dwellings caused by the earthquake on January 13, 2001.

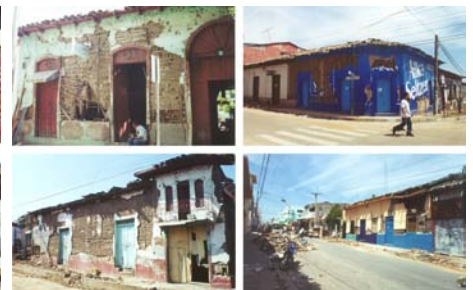
Figure 19. Structural damage to bahareque dwellings in the city of San Vicente caused by the earthquake on February 13, 2001.
