Royal Norwegian Council for Scientific and Industrial Research

TECHNICAL REPORT
Field Maintenance Report
1 January - 30 September 1971

NORSAR Report No 32
Budget Bureau No 22-RO293

Field Maintenance Report

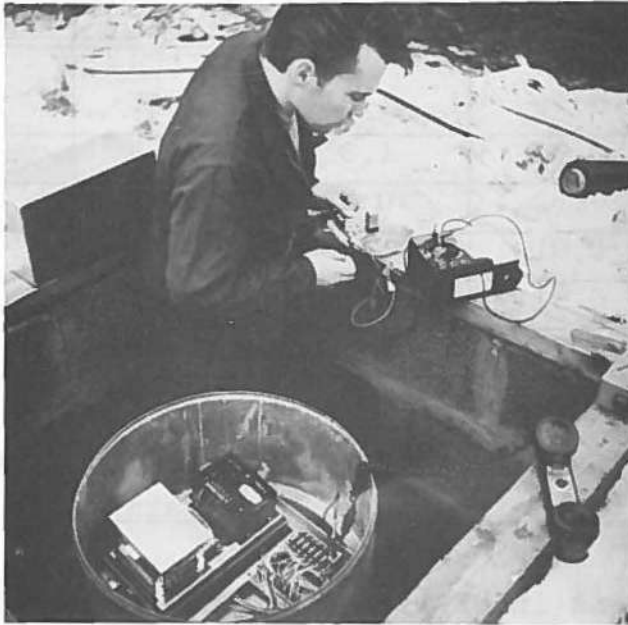
Figure 4.3 Technician adjusting damping resistor at the WHV.

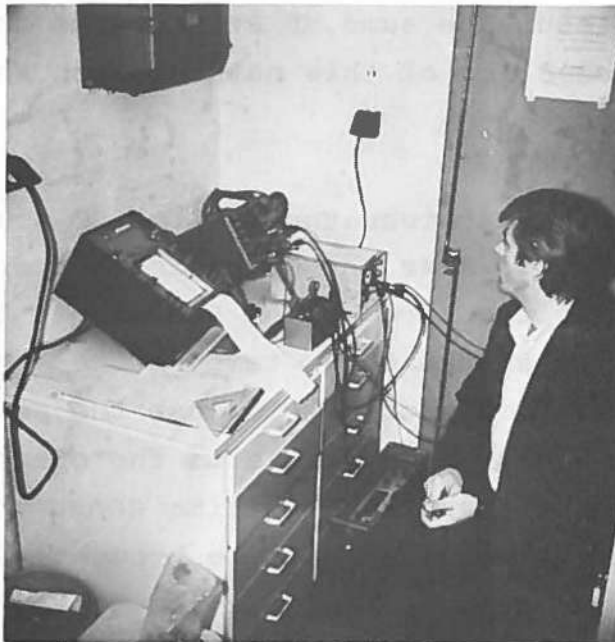
Figure 4.4 Test setup in the CTV for field test.

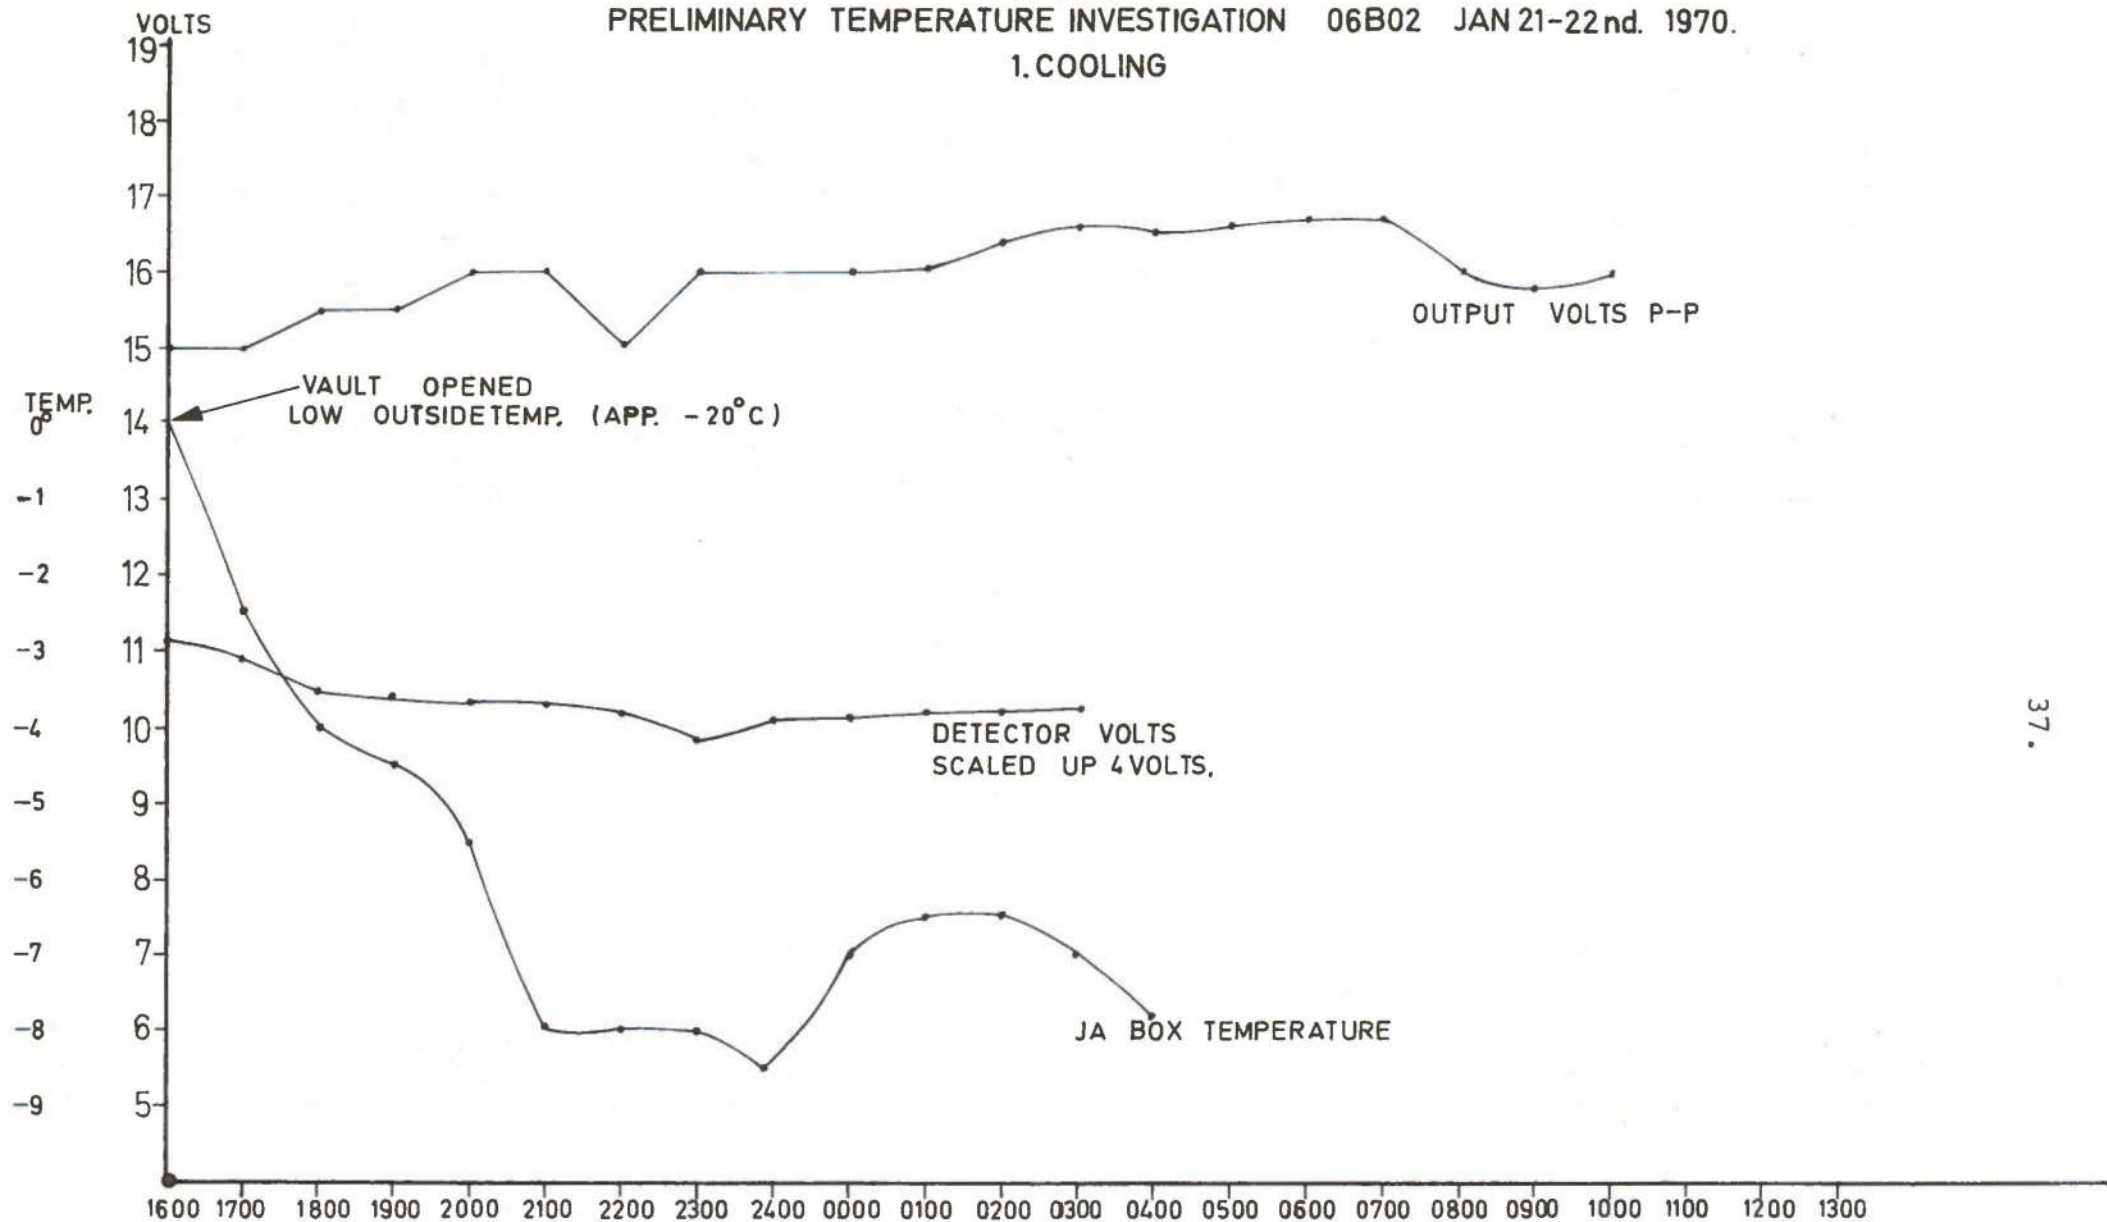
Figure 5.2

The attached curve indicates the decrease in detector voltage with decreasing temperature from 7.1 Volt at 0 degrees to 5.2 Volts at -8°C. (Table 5.2, Fig 5.2, 5.3).

NORSAR
 PRELIMINARY TEMPERATURE INVESTIGATION 06B02 JAN 21-22nd. 1970.
 1. COOLING

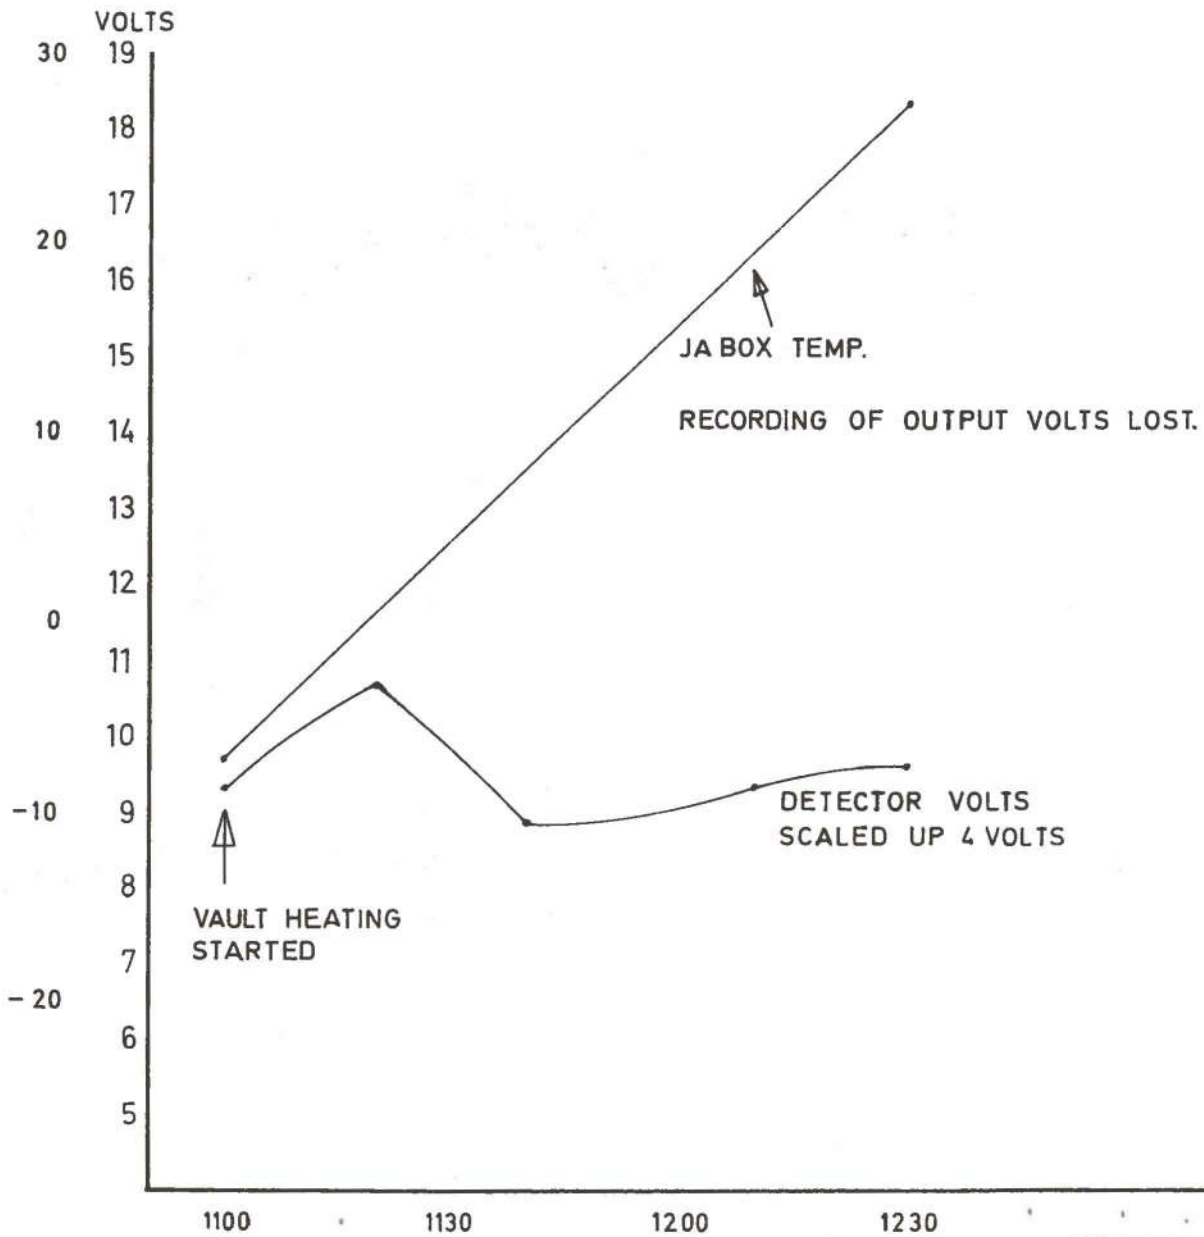
Figure 5.3

NORSAR
PRELIMINARY TEMPERATURE INVESTIGATION 06B02 JAN 21-22nd. 1970.
2. HEATING.

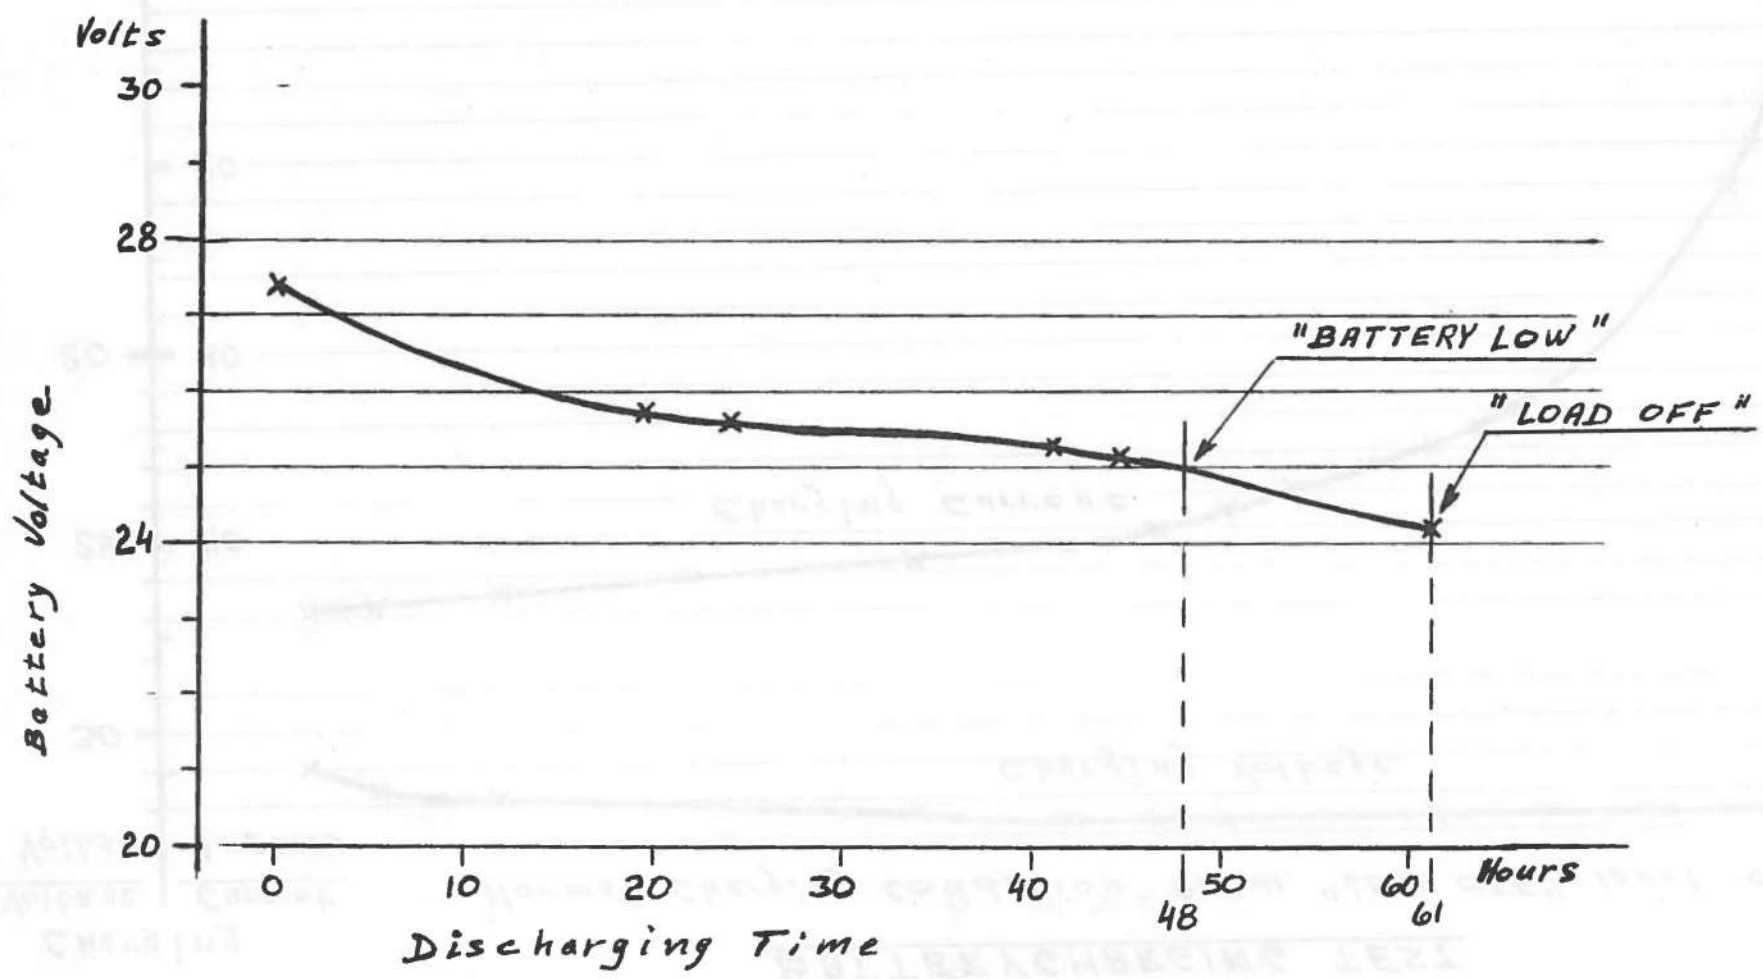
The main power was disconnected, and the normal load was carried by the battery. The result is shown in figure 6.1.

Figure 6.1 Discharging of Fully Charged Battery.

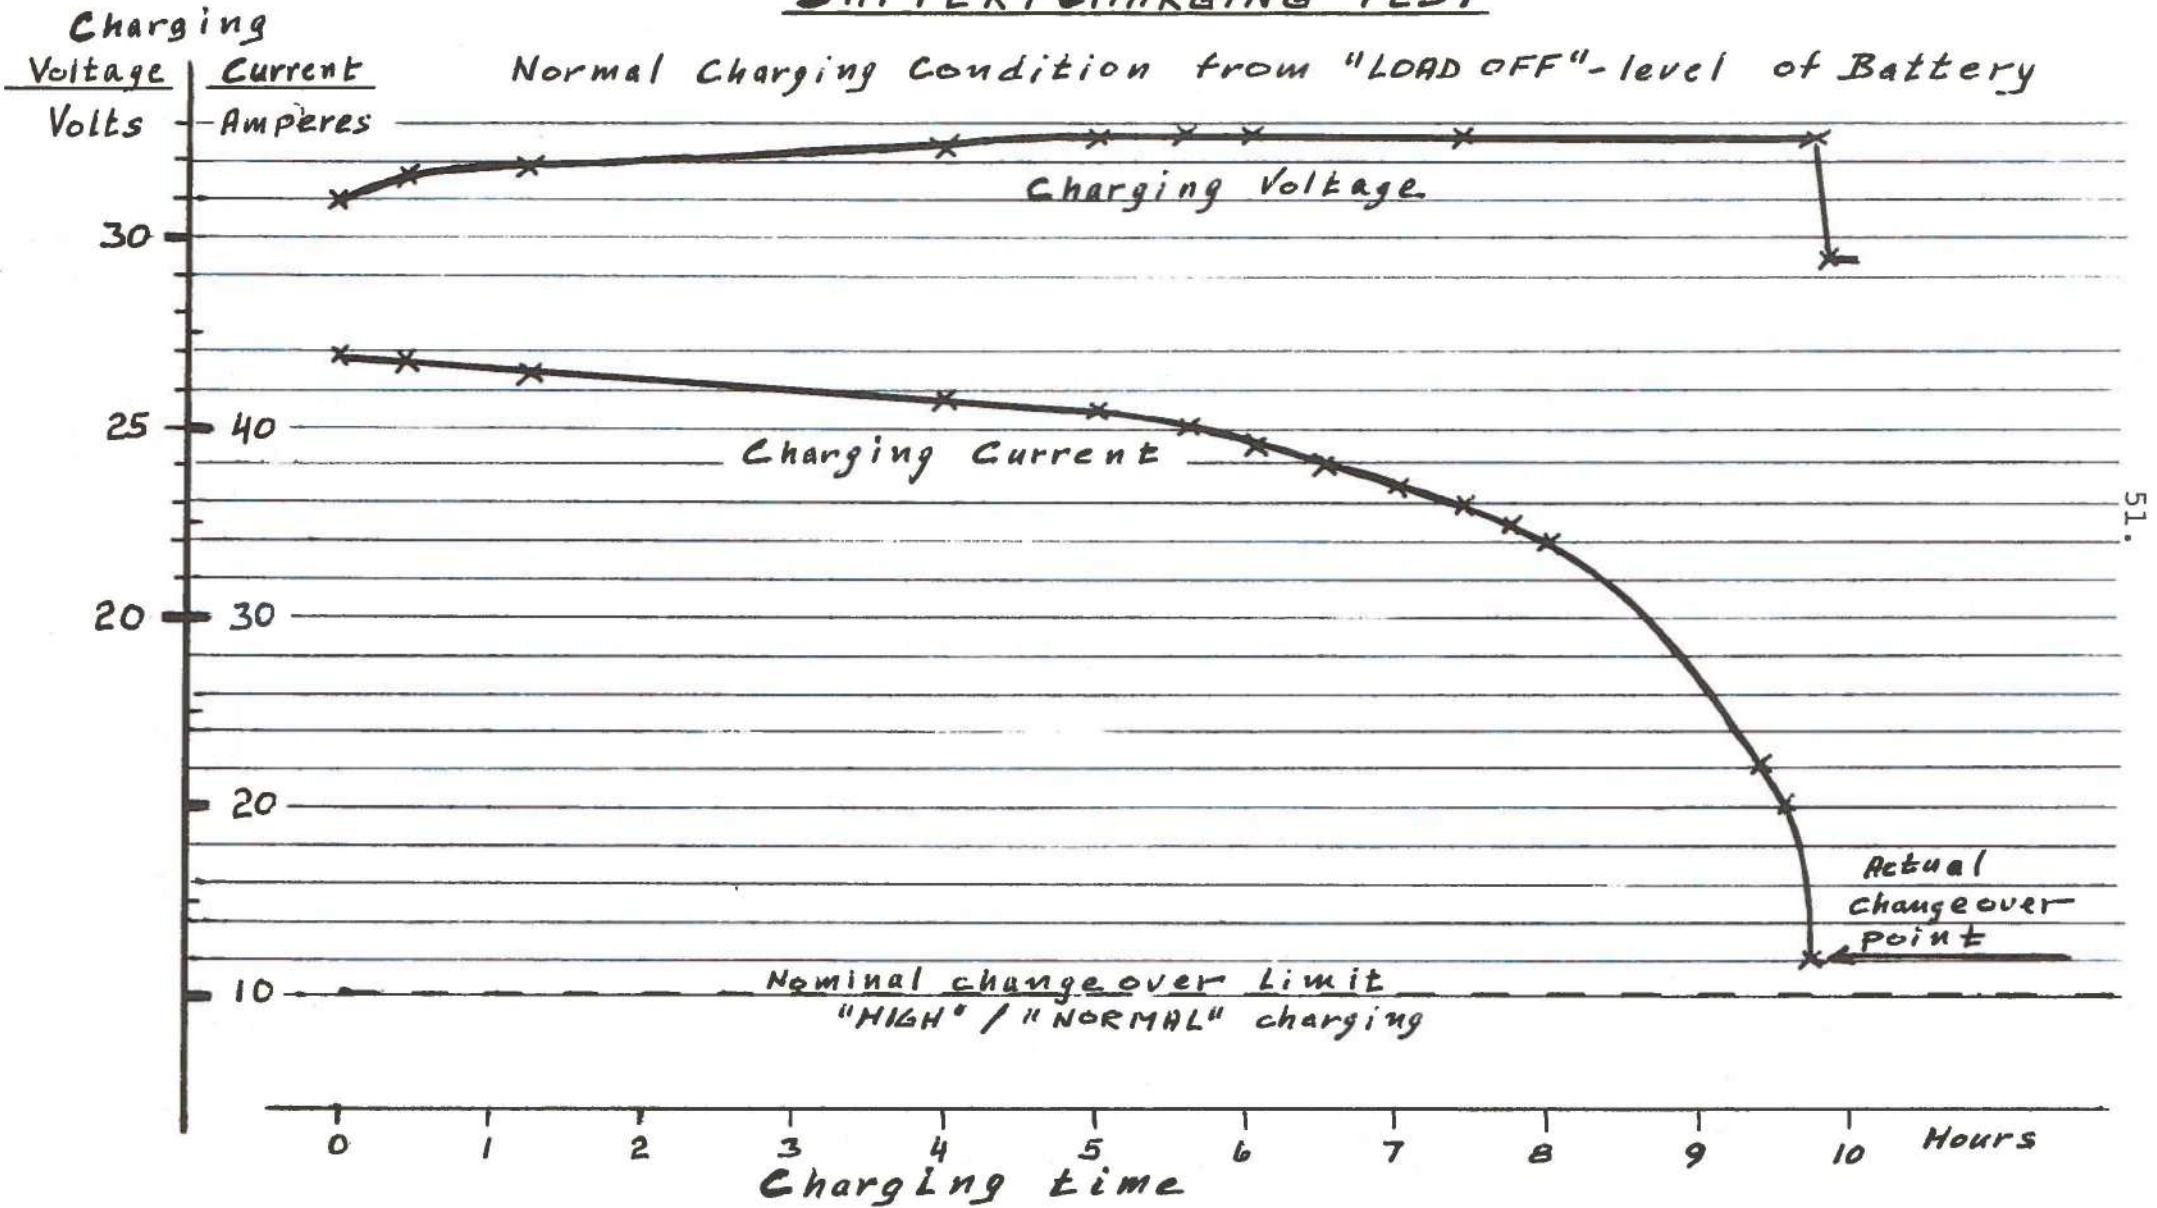
Figure 6.2 Normal Charging Condition from "LOAD OFF"-level of Battery.

Because the charging current quickly drops to nearly the same level as with "NORMAL" or maintenance charging and the gassing does not seem to be too inconvenient, it should not be necessary to set the Time Delay Relays lower than 9 - 10 hours, which is necessary for quick recharging of the batteries after mains dropout. See figure 6.2.
